# LRIS Blue Channel Shutter History

Updates	Author
2006 September 27 Original Version	Marc Kassis
2010 June – Following Failure	Marc Kassis
2012 September	Luca Rizzi
2013 September	Luca Rizzi

This document is a status report for the suite of blue side shutters in use at the Keck Observatory. This is to provide a history of service and track when the shutters have been replaced inside LRIS.

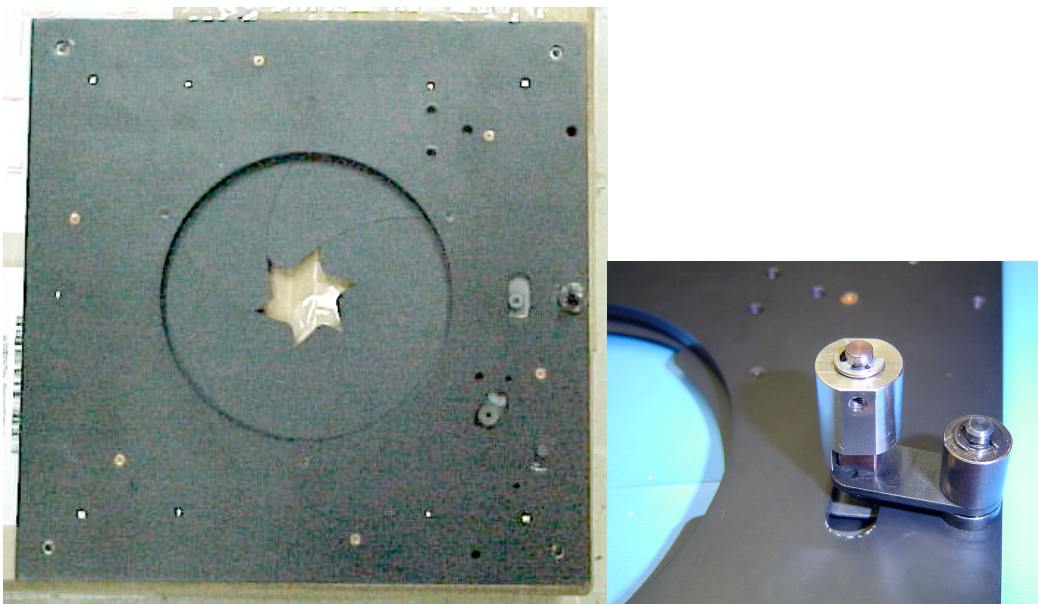
*Figure 1: Face on view of a Pronto E/100 shutter used on the LRIS blue channel (left). The shutter is slightly open. The pivot arm has been removed in this view. At right, the pivot arm and custom pin are shown. The thin rods thread in the tapped hole seen in this view of the custom pivot pin.*

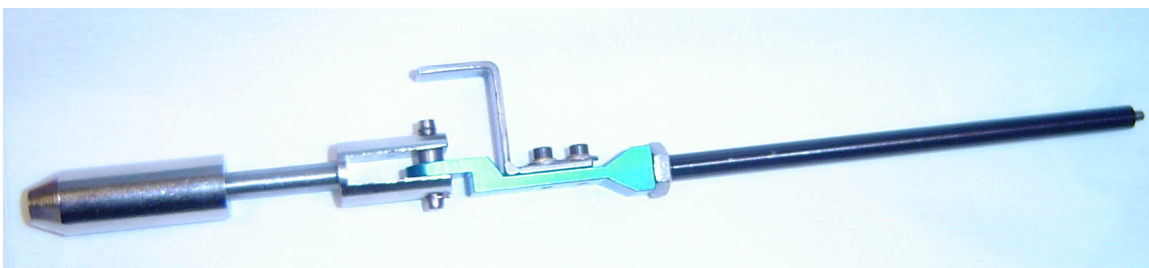
*Figure 2: Assembly of the armature and the thin threaded rod. The armature at the left of the image fits inside a solenoid.*
